# MICROSCOPIC EXAMINATION OF STEEL

HENRY FAY, Ph. D., D. Sc.

*Professor of Analytical Chemistry, Massachusetts Institute of Technology  
Consulting Metallurgist, Watertown Arsenal*

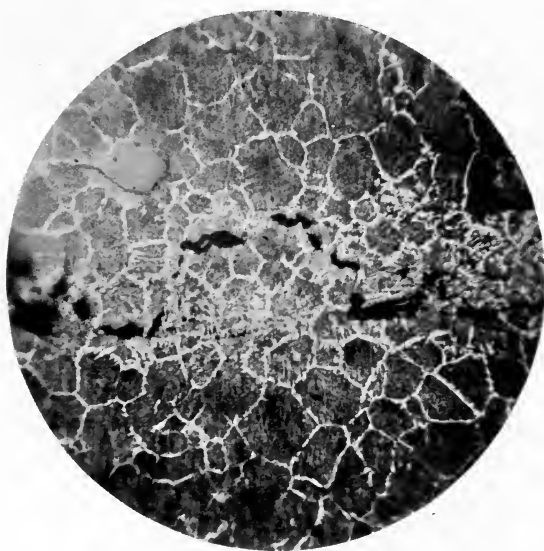
**PHOTOGRAPH NO. 53. X50.**

**Twelve-inch gun. Microstructure showing slag and fissures.**

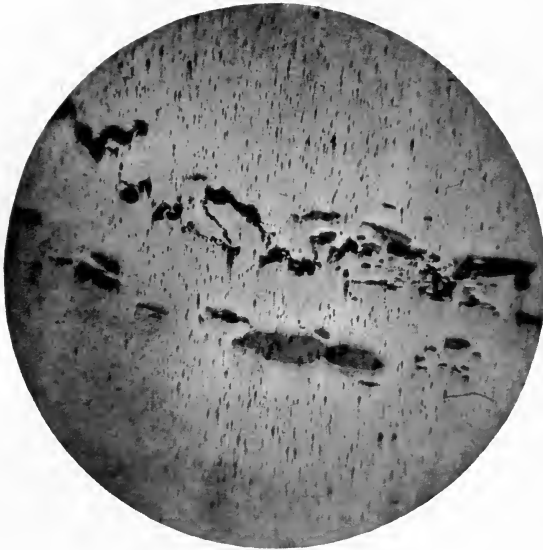
PHOTOGRAPH NO. 54. X50.  
Twelve-inch gun. Slag in unetched specimen.

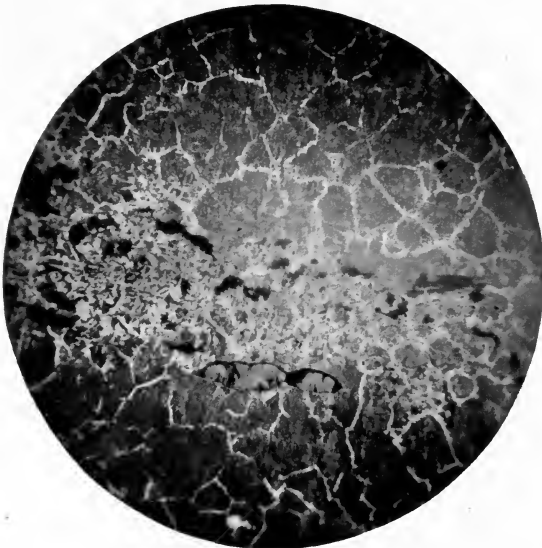
PHOTOGRAPH NO. 55. X50.  
Twelve-inch gun. Same area as No. 54, etched with alcoholic nitric acid.
